Cost Effectiveness of Legacy Sediment Mitigation at Big Spring Run in Comparison to Other Best Management Practices in the Chesapeake Bay Watershed

Legacy sediment erosion hot spots: A cost-effective approach for targeting water quality improvements

Targeting Erosion Hotspots, Legacy Sediment Terraces and Canopy Layers with LiDAR Point Cloud Data

Lancaster GIS Day, 11/11/19

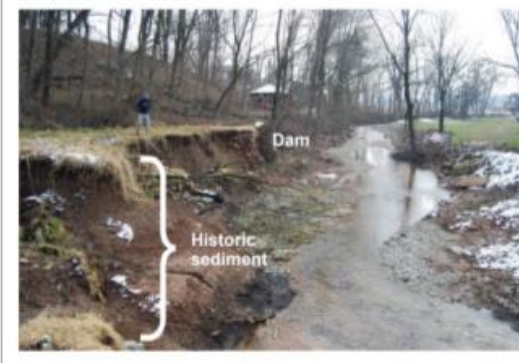
Figure 1

Erosion of legacy sediment following breach of Strobers Dam in Pennsylvania in 2011. Bank sediments are upstream of the breached dam, and the top of the bank matches the top of the dam.

ally or otherwise, long-term elevated pollution loads have been left behind along numerous stream systems in the mid-Atlantic region. These loads are concentrated at LS “hot spots,” characterized by near-vertical stream banks carved into the previously accumulated sediment (figure 1). (Here, we consider LS erosion hot spots as stream lengths that produce above $0.05 \text{ to } 1 \text{ ft}^{-1} \text{ yr}^{-1}$ [$0.15 \text{ Mg m}^{-1} \text{ yr}^{-1}$] of sediment erosion over at least a span of 2,000 ft [610 m]). Subsequent research has shown that LS mitigation—through removal of sediment to restore the wetland or other aquatic ecosystem long buried behind historic stream impoundments (Hartzaft et al. 2011)—is a highly effective form of sediment, phosphorus (P), and nitrogen (N) abatement when implemented at identifiable LS erosion hot spots (Sharpley et al. 2013; Inamdar et al. 2017). However, less is known about the cost-effectiveness of LS mitigation projects in terms of their cost per unit of pollution reduced, especially in comparison to other NPS reduction practices.

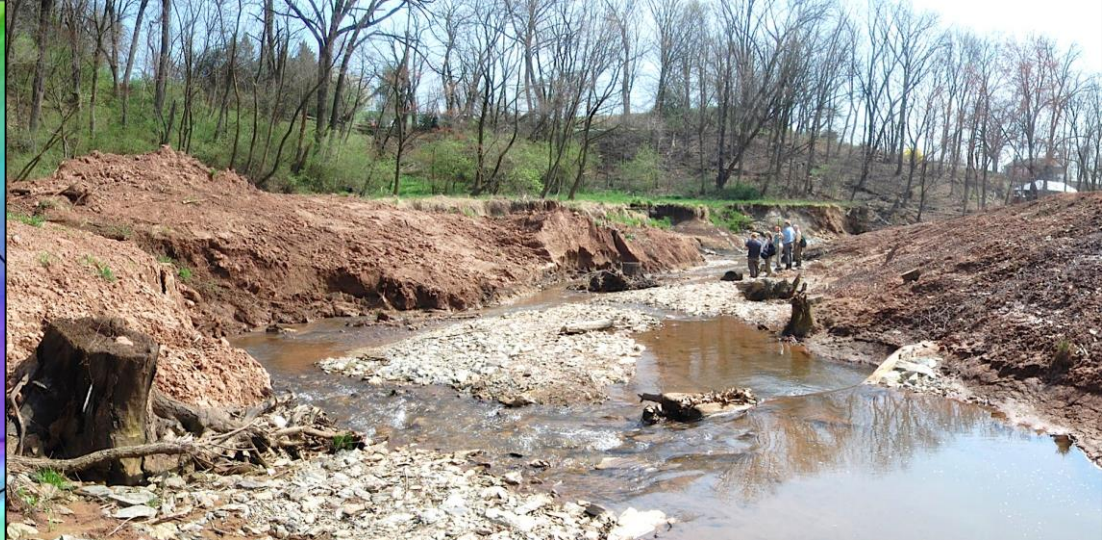
Indian Run, PA – Stobers Dam breach, 2011, Height 14 ft

2014 lidar DEM (USGS/NOAA)
Breach in 2011

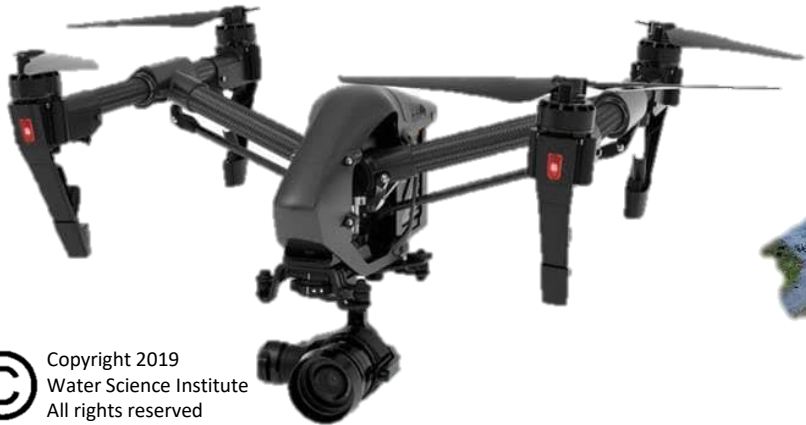
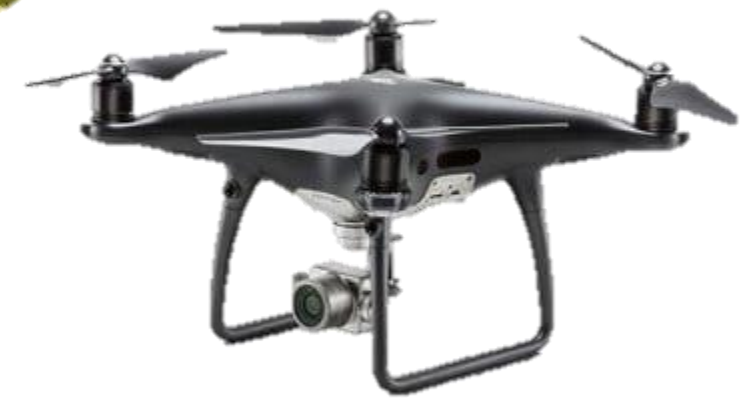
Drone Photogrammetry

Big Spring Run Restoration Site, Lancaster County. Drone Flight: May 2018.

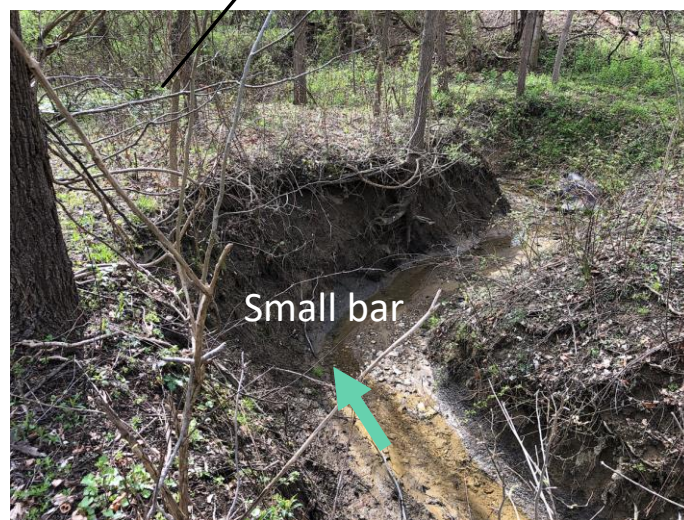
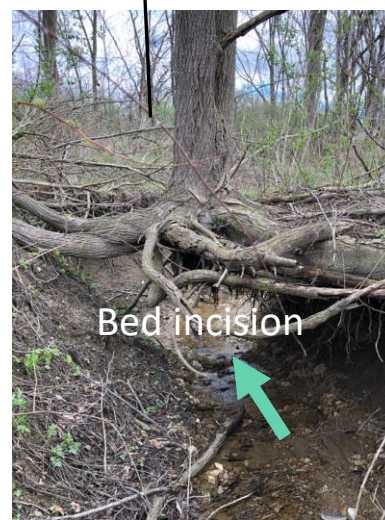
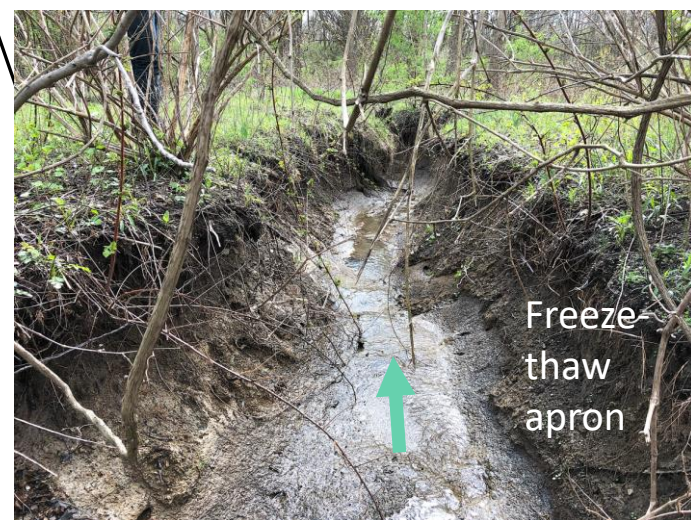
Knickpoint

Small bar

Bed incision

Freeze-
thaw
apron

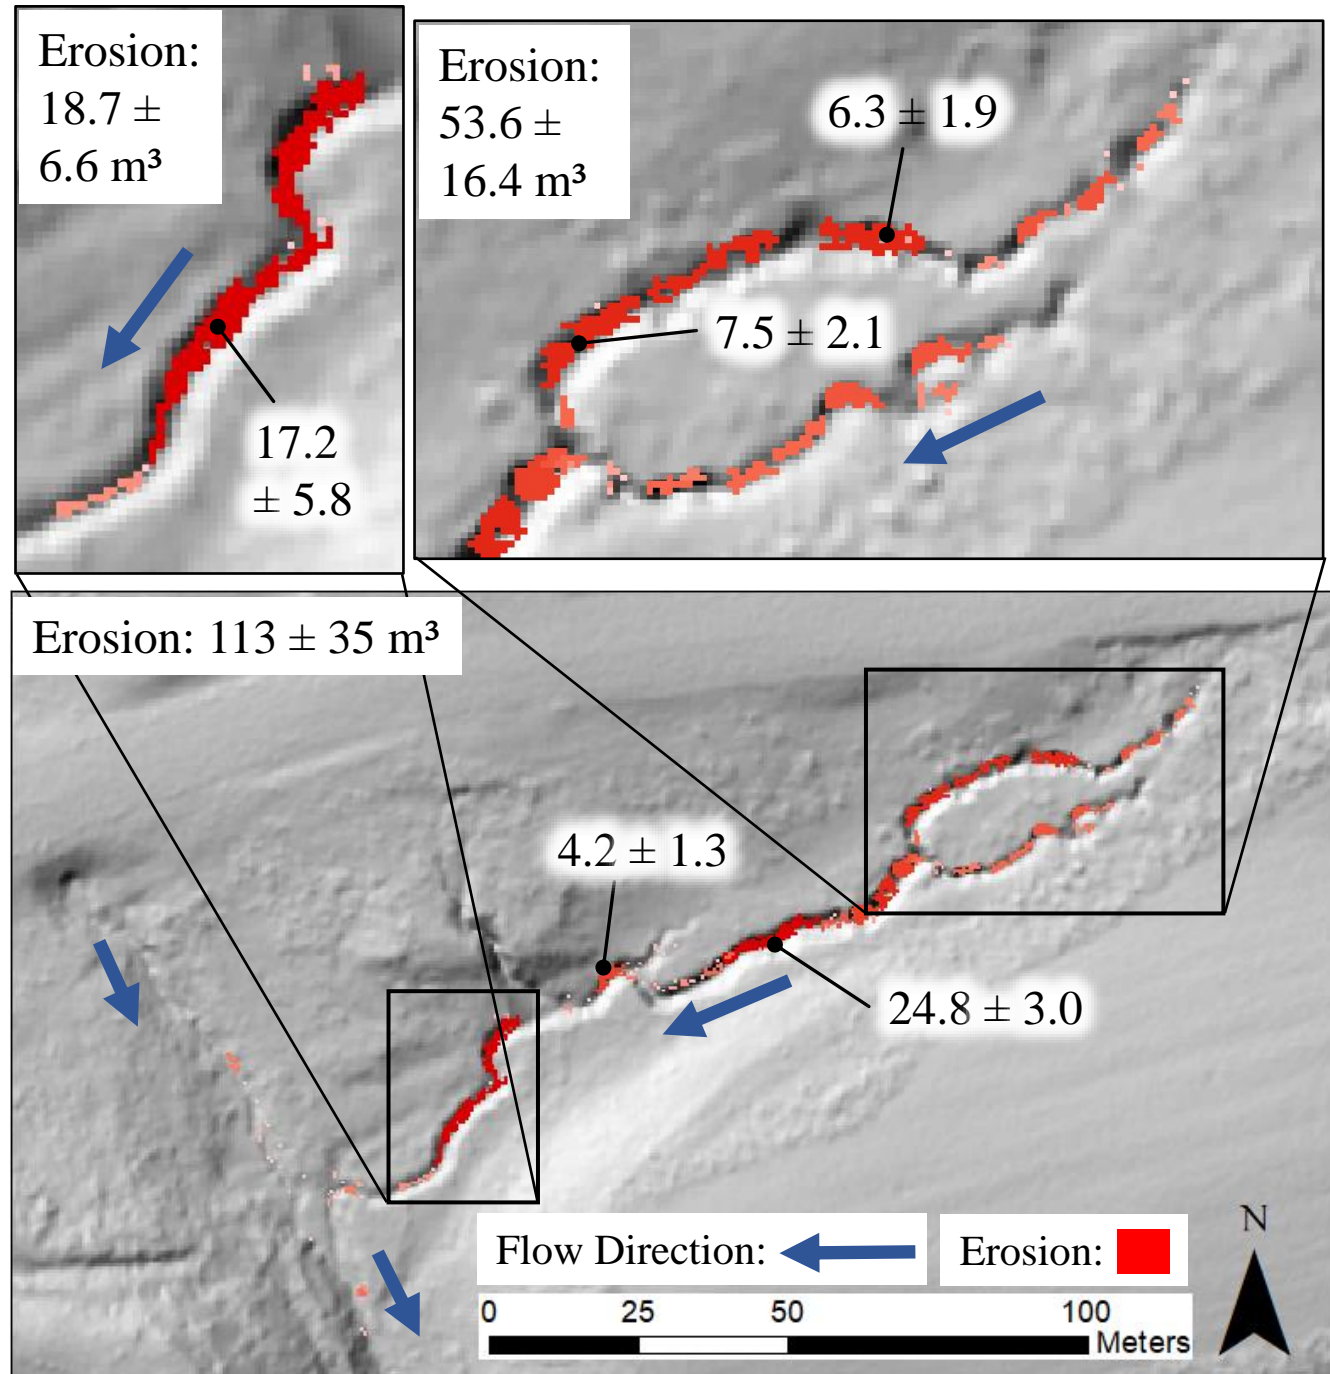
Veterans Park, Dauphin County

Slopesshade from
2016 USGS QL2
Lidar.

Lidar Date	3-24-2016
Drone Flight Date	11-28-2018
Period Duration	2.7 years 980 days
Stream length	285 m 935 ft
Total erosion volume	113 ± 35 m ³ 147 ± 45 tons 294,000 ± 90,000 lbs
Erosion/year	42 ± 13 m ³ /yr 59 ± 18 tons/yr 118,000 ± 36,000 lbs/yr
Erosion/stream length/year	~0.15 m ³ /m/yr ~0.06 tons/ft/yr ~126 lbs/ft/yr
